## Snubber Valves

## Snubber Valve Failure

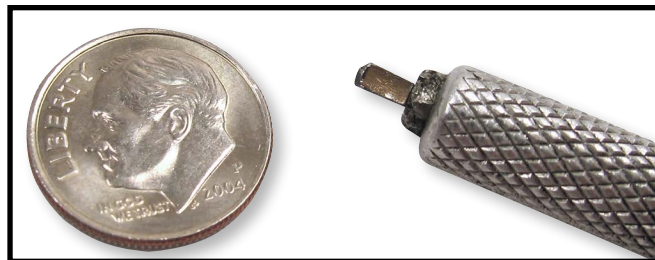
We've found pieces of broken off snubber valve tabs (attached to a magnet in the photo below) in the high–pressure oil inlet area of 6.0 L Injectors. This resulted in misfire complaints. After finding at least one broken tab, you need to determine if any other tabs are broken and if they are, that they're all accounted for. We suggest you disassemble the valves from both cylinder heads to determine how many tabs are broken off. If all tabs are not found in the injector(s), it is suggested you remove the rail end plugs and flush the rail to locate them.

**Note:** To replace valves on 2004¼–2006¼ models, you will need to buy the complete stand pipe/valve assembly: 5C3Z9A332A 6E7Z9A332A

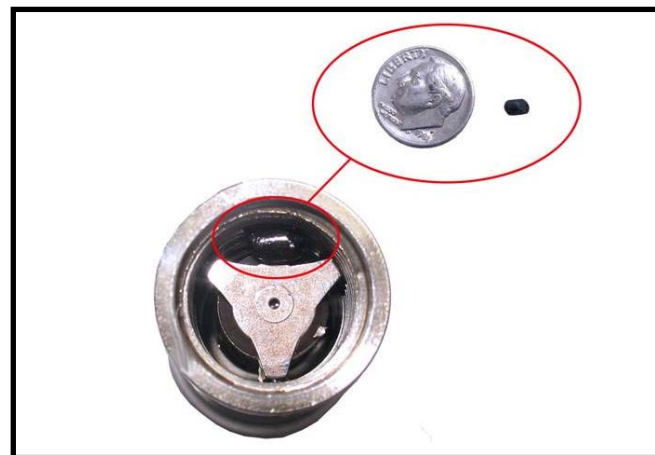
Debris in the snubber valve area can also lead to a driveability complaint. The non–ferrous piece shown in the photo at right (it appears to be a plastic fragment of the frame of the IPR valve screen or the high–pressure oil reservoir filter) was found in the snubber valve assembly of an engine that was being diagnosed for a flutter/vibration complaint on one bank. The position of the debris, wedged between the snubber plate and its bore, had no effect on the flow of the high–pressure oil inlet into the rail but prevented or reduced the snubber effect of the valve when ICP was reduced. Although no codes were present to lead the technician directly to this malfunction, in hindsight, we suspect the IPR duty cycle would show high variation at constant RPM.
