OREGON FUEL INJECTION, INC.

2011 – 2016 6.7L Ford Powerstroke Diagnostics

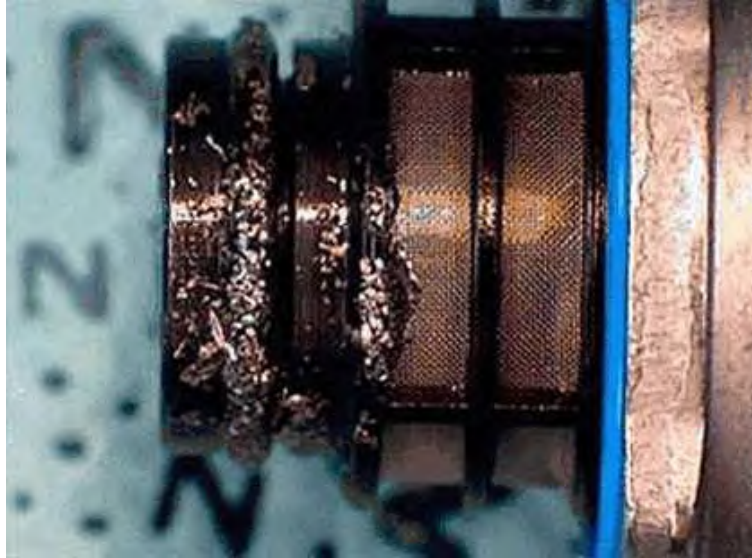
Note: The CP4.2 pumps are not as durable as the CP3 pumps. Poor fuel supply, contamination, and/or running them out of fuel (plugged fuel filter) will cause them to fail. When they fail it is often catastrophic and they send metal particles throughout the high-pressure side of the fuel system, causing further damage.

Metal contaminated fuel pressure regulator
(Courtesy GM)

1. Check the fuel supply system first: see “Fuel Supply” above.
2. Before condemning the pump for a starting issue, you need to be certain that the high pressure fuel system is not leaking the pressure. Check the injector return and the pressure control valve in the fuel rail.
3. If there has been a major contamination issue with dirt and or water, then it is very likely that the high pressure pump will need to be replaced. The injectors are typically damaged as well if the pump is damaged.
4. If the pump will not build the desired pressure while cranking and everything else checks OK, remove the regulator from the pump and inspect for metal (see picture below). If there is metal debris, the entire fuel system will need to be cleaned and/or replaced.
