**APTБ 09/16**

## **SUBJECT: 6.4L Power Stroke®/MaxxForce® 7 High-Pressure Fuel Pump Connectors**

**July 11, 2016**

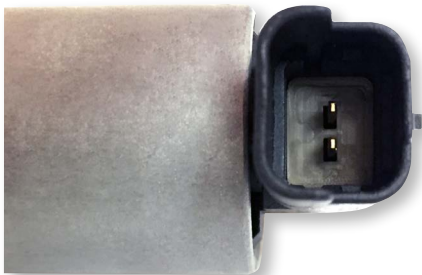
Early production pumps were equipped with rubber connector spacers in the cavity of the VCV and PCV connectors, see images below. These spacers must be removed and discarded prior to plugging in the harness connectors. If these spacers are not removed the harness connectors may not lock in place properly, resulting in possible fault codes and low power concerns.

**Connector with Spacer Installed**

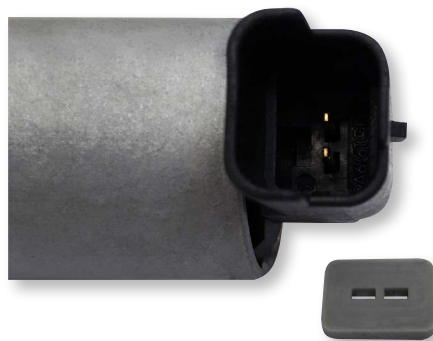
**Connector with Spacer Removed**

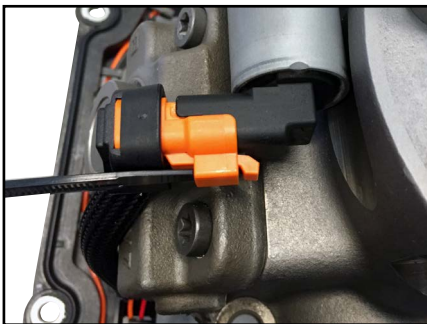
Two tie straps are supplied with all high-pressure fuel pump installation kits. These tie straps must be installed on the VCV and PCV harness connectors prior to reinstalling the high-pressure fuel pump cover. The purpose of these tie straps is to keep the harness connectors locked in place. It is an indication that the harness connector is not fully engaged and locked if the tie strap cannot be inserted through the harness connector slot, see images below.

**Connector Not Fully Engaged/  
Locked**

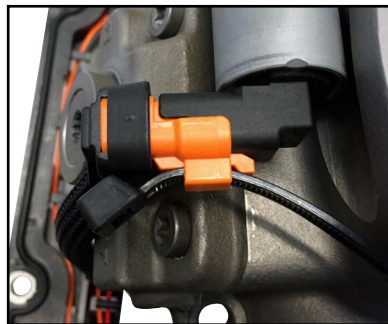
**Connector Locked with Tie Strap  
Inserted**

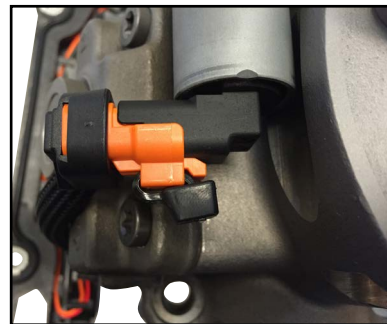
**Connector Locked with Tie Strap  
Secured**
